DEBRIS/ICE/TPS ASSESSMENT  
AND  
PHOTOGRAPHIC ANALYSIS  
OF  
SHUTTLE MISSION STS-32R

January 9, 1990

Gregory N. Katnik  
NASA/Kennedy Space Center  
TV-MSD-22

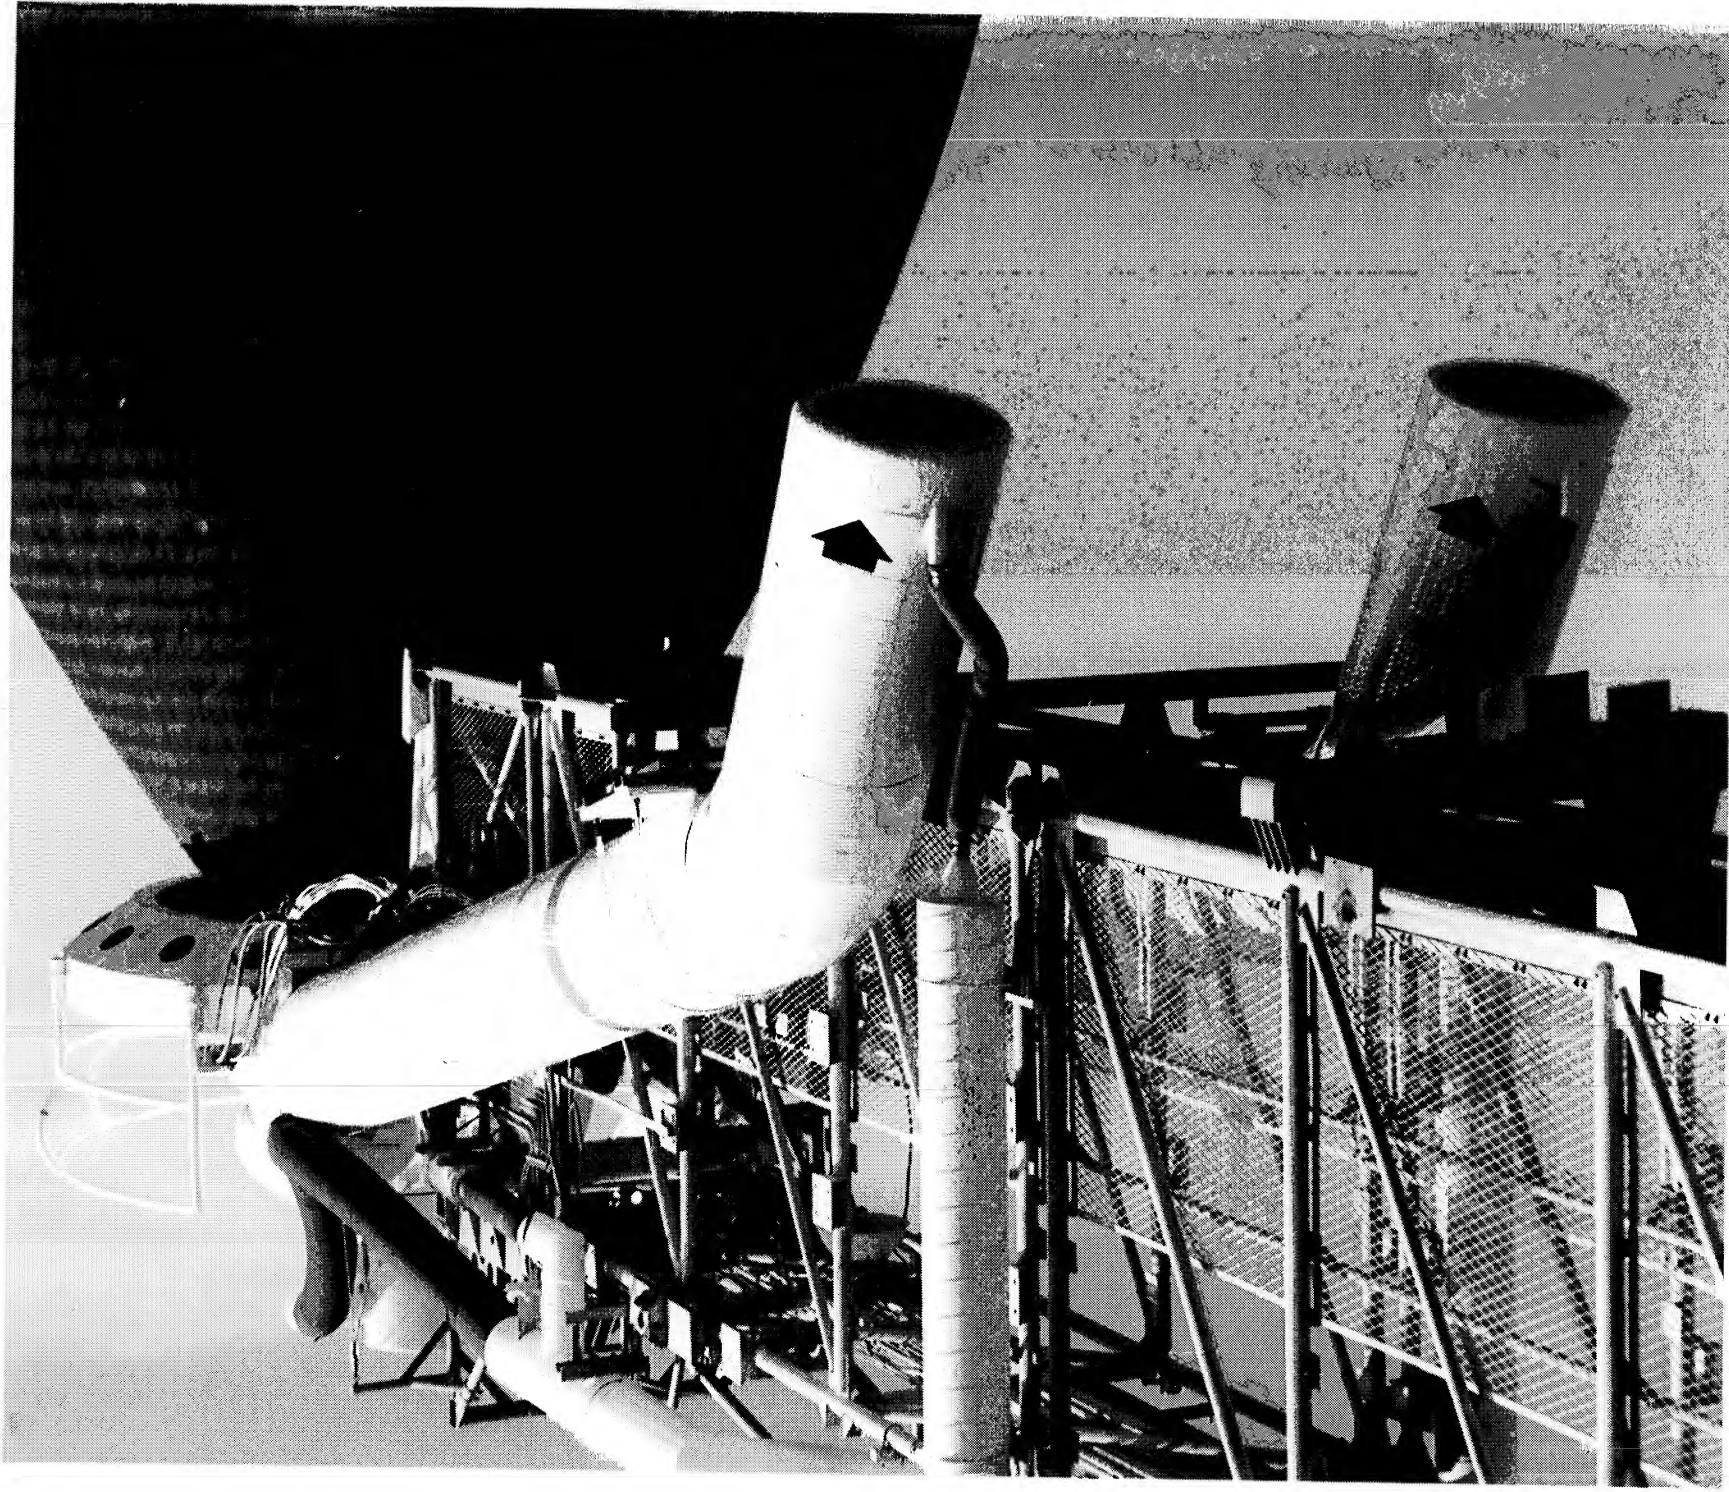
Absence of hydro diverters, which had not been installed on the  
GOX vent ducts, eventually caused the formation of icicles.

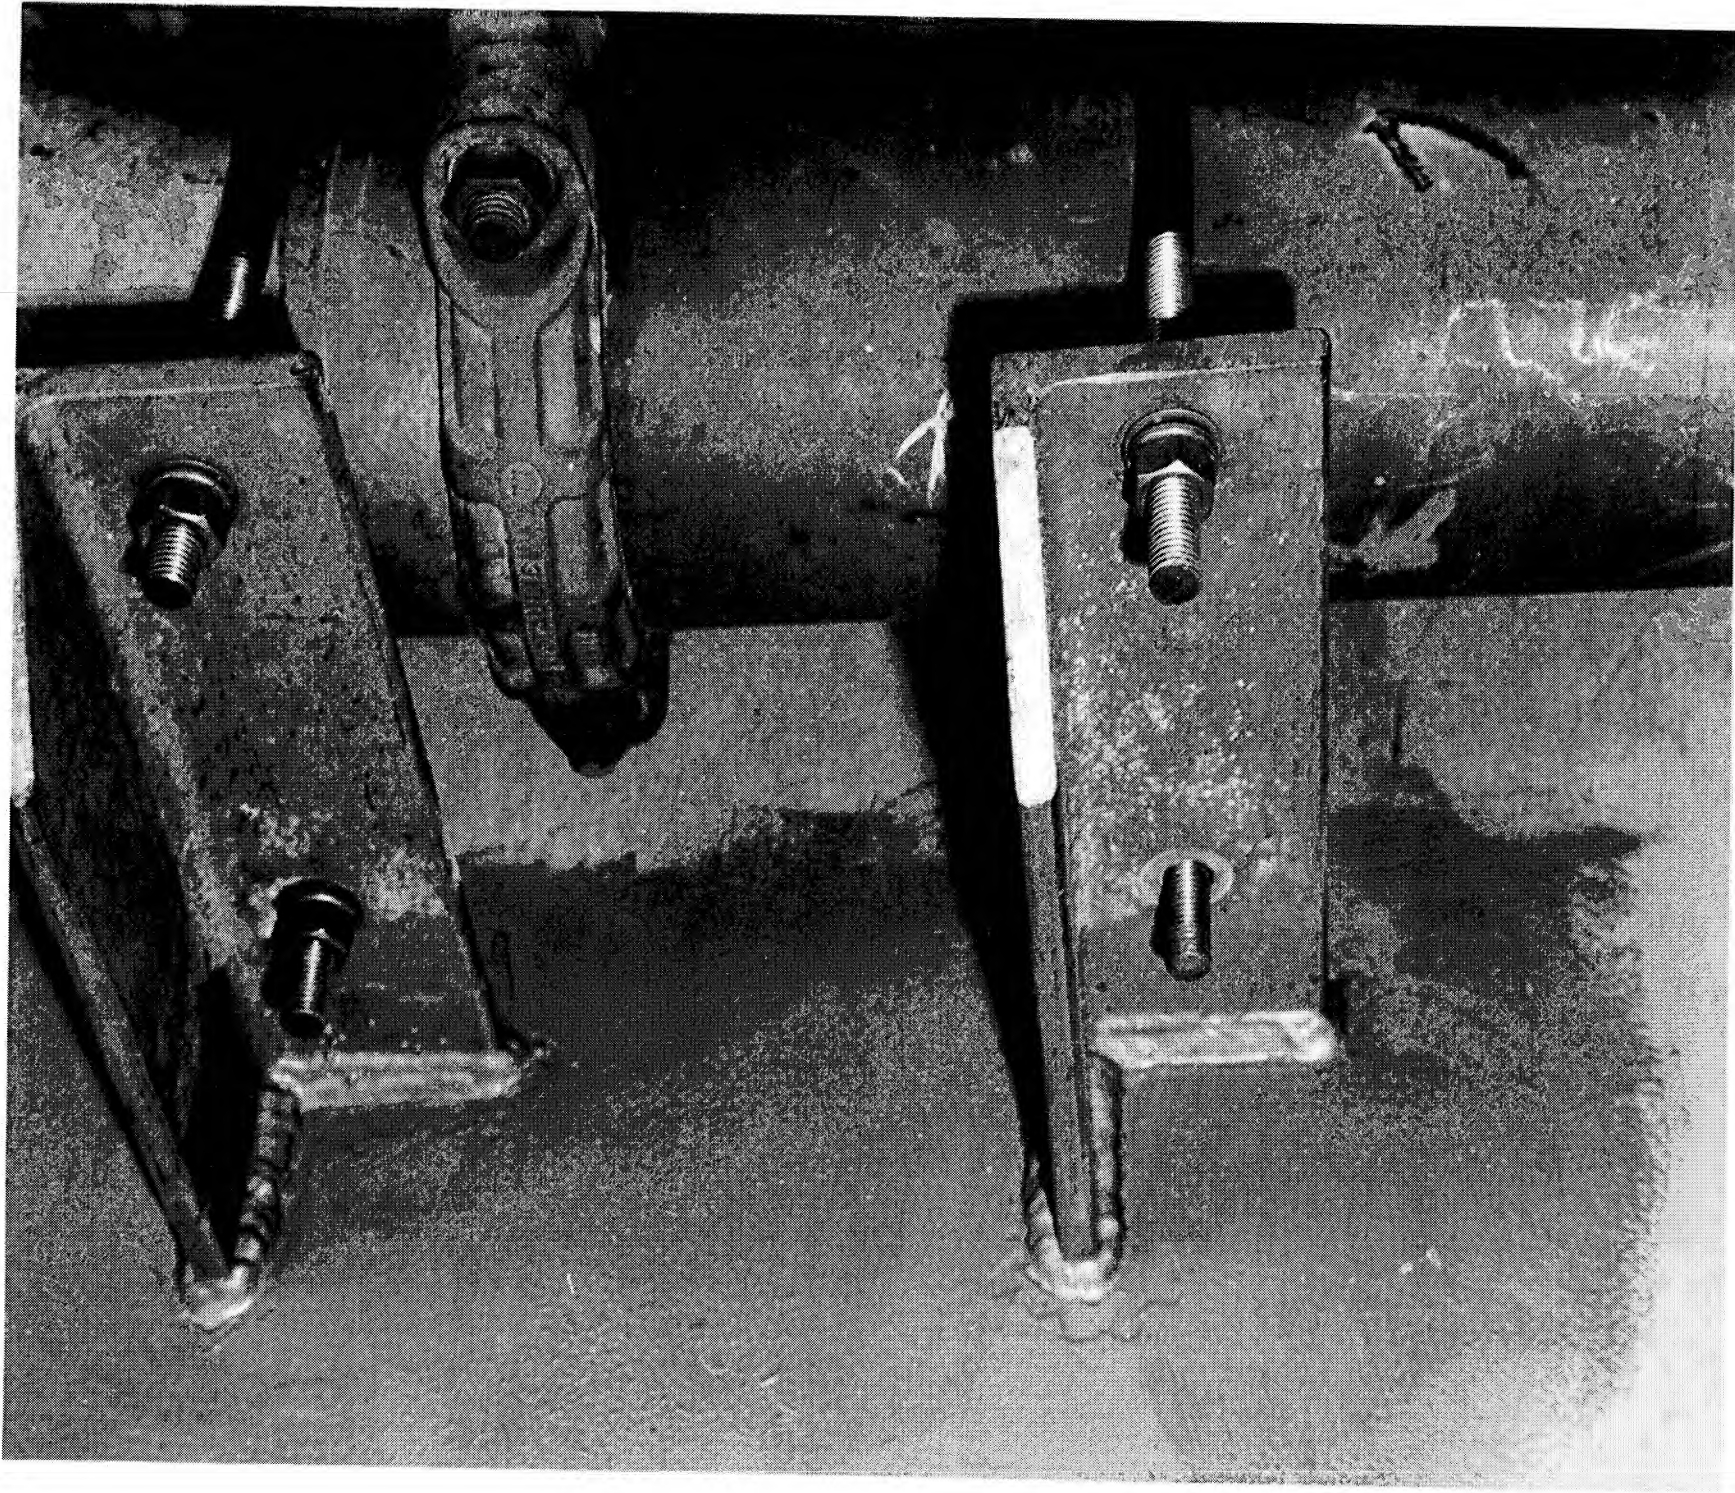
A U-bolt on the sound suppression pipe near the SSME exhaust  
hole was missing a nut and washer

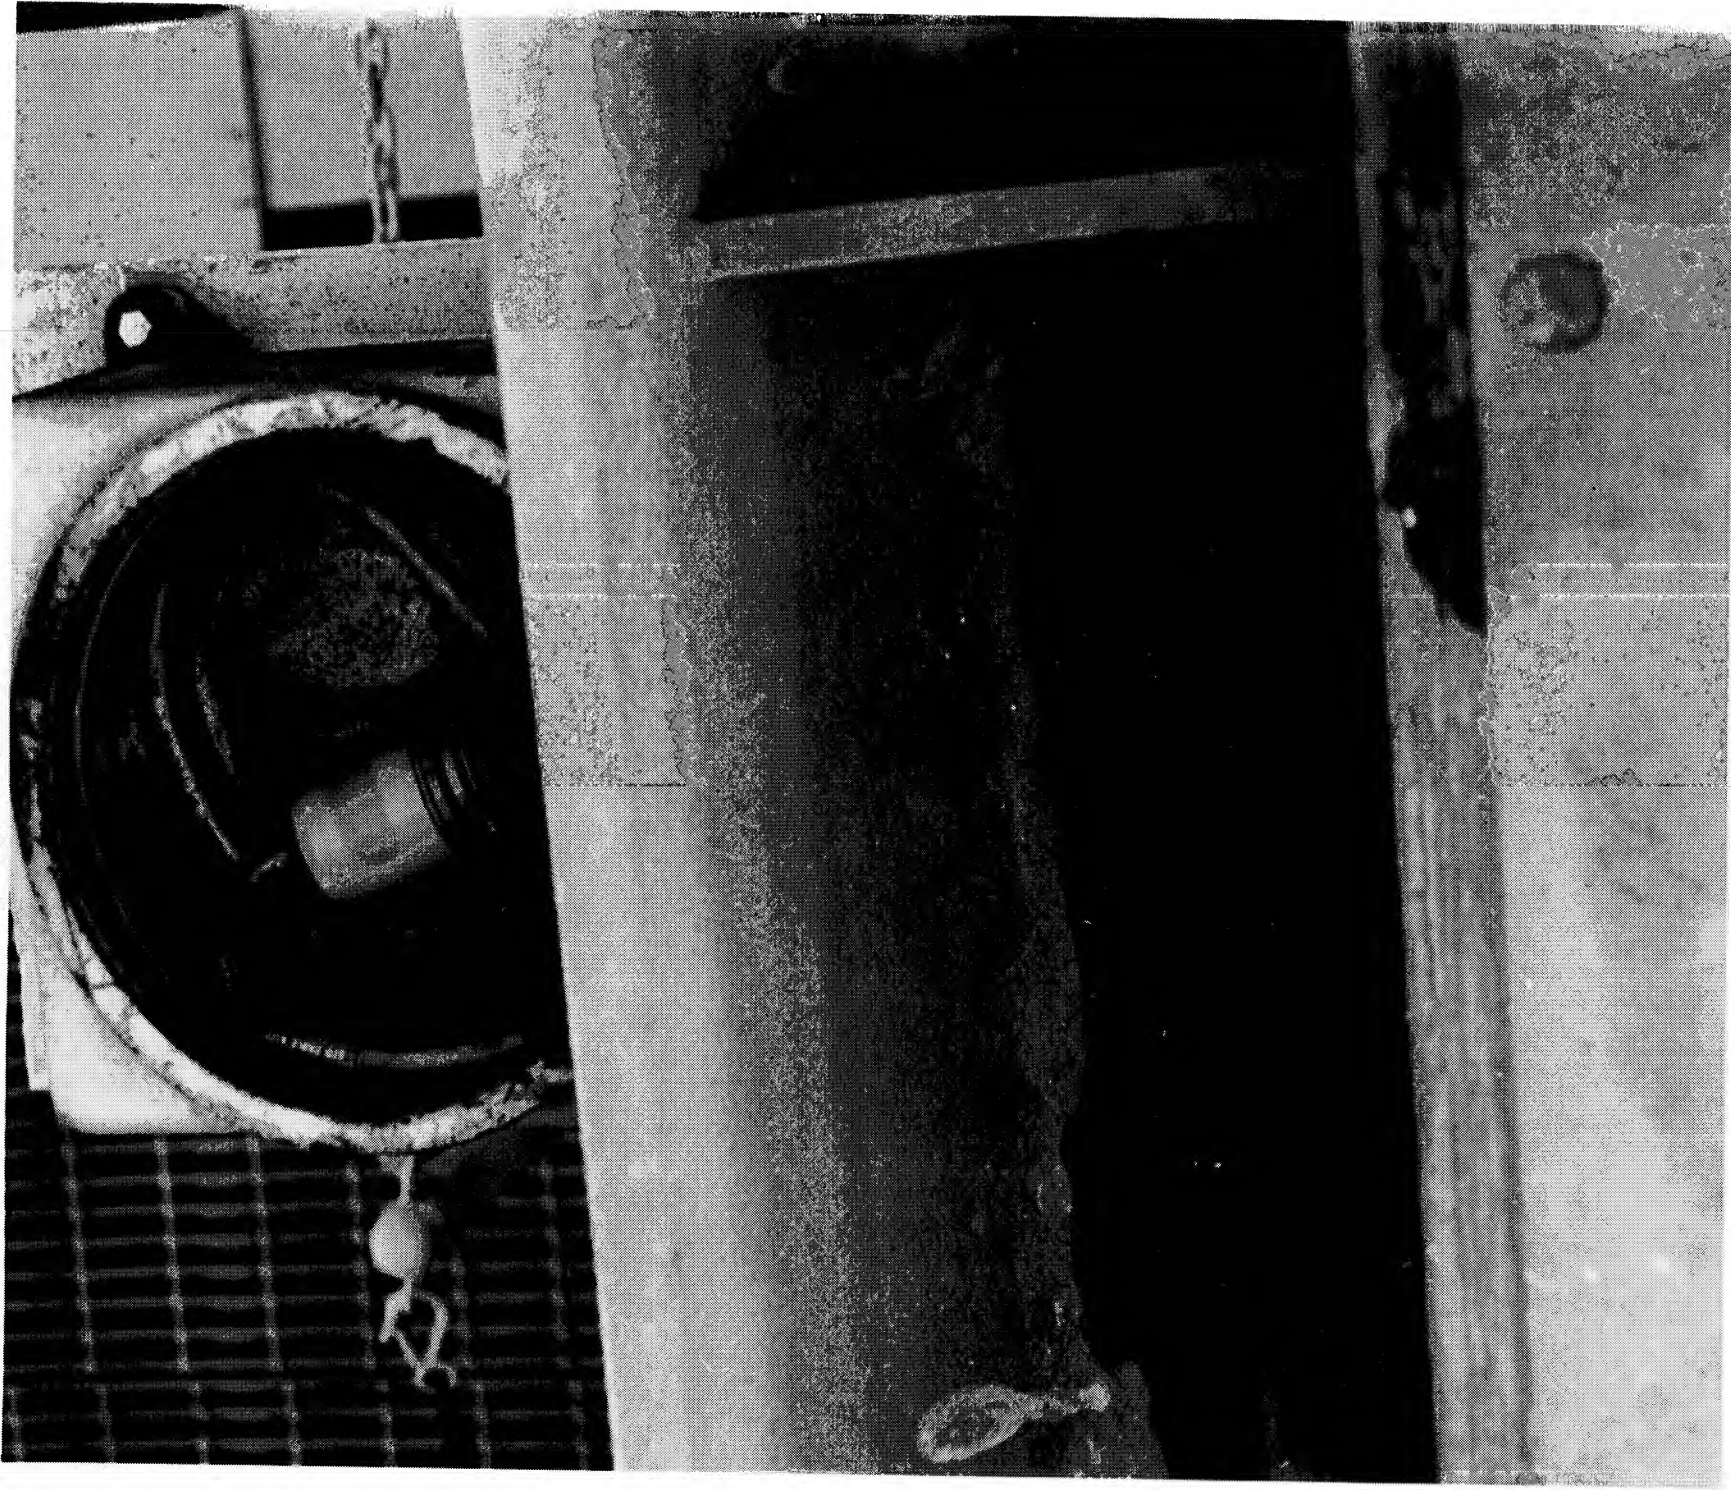
A cover was missing from the electrical box on the MLP NW side

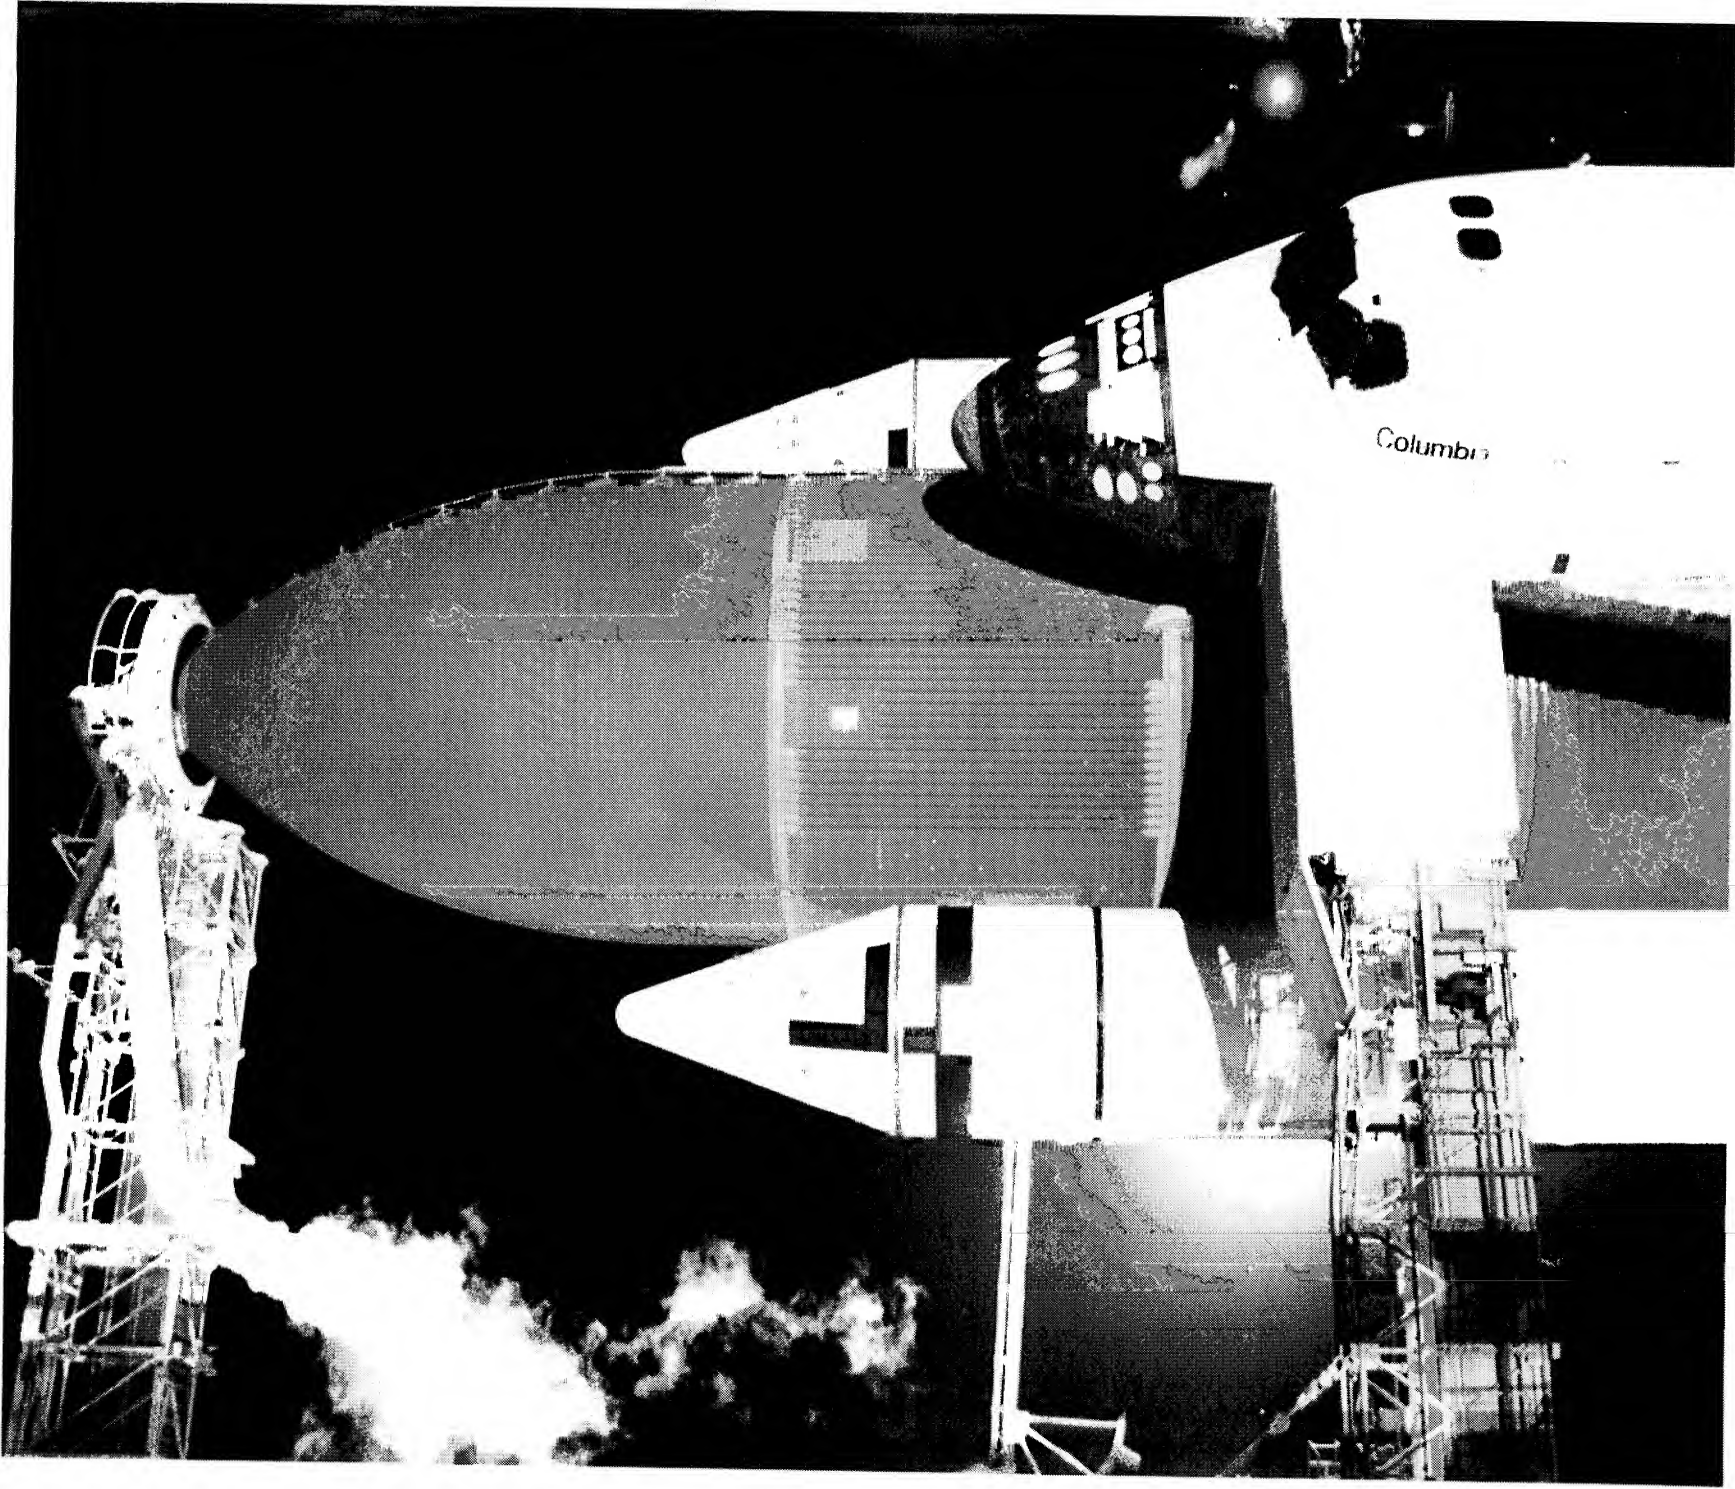
No TPS anomalies occurred on the External Tank acreage areas.  
GOX vapors were blown away from the vehicle by southerly winds.

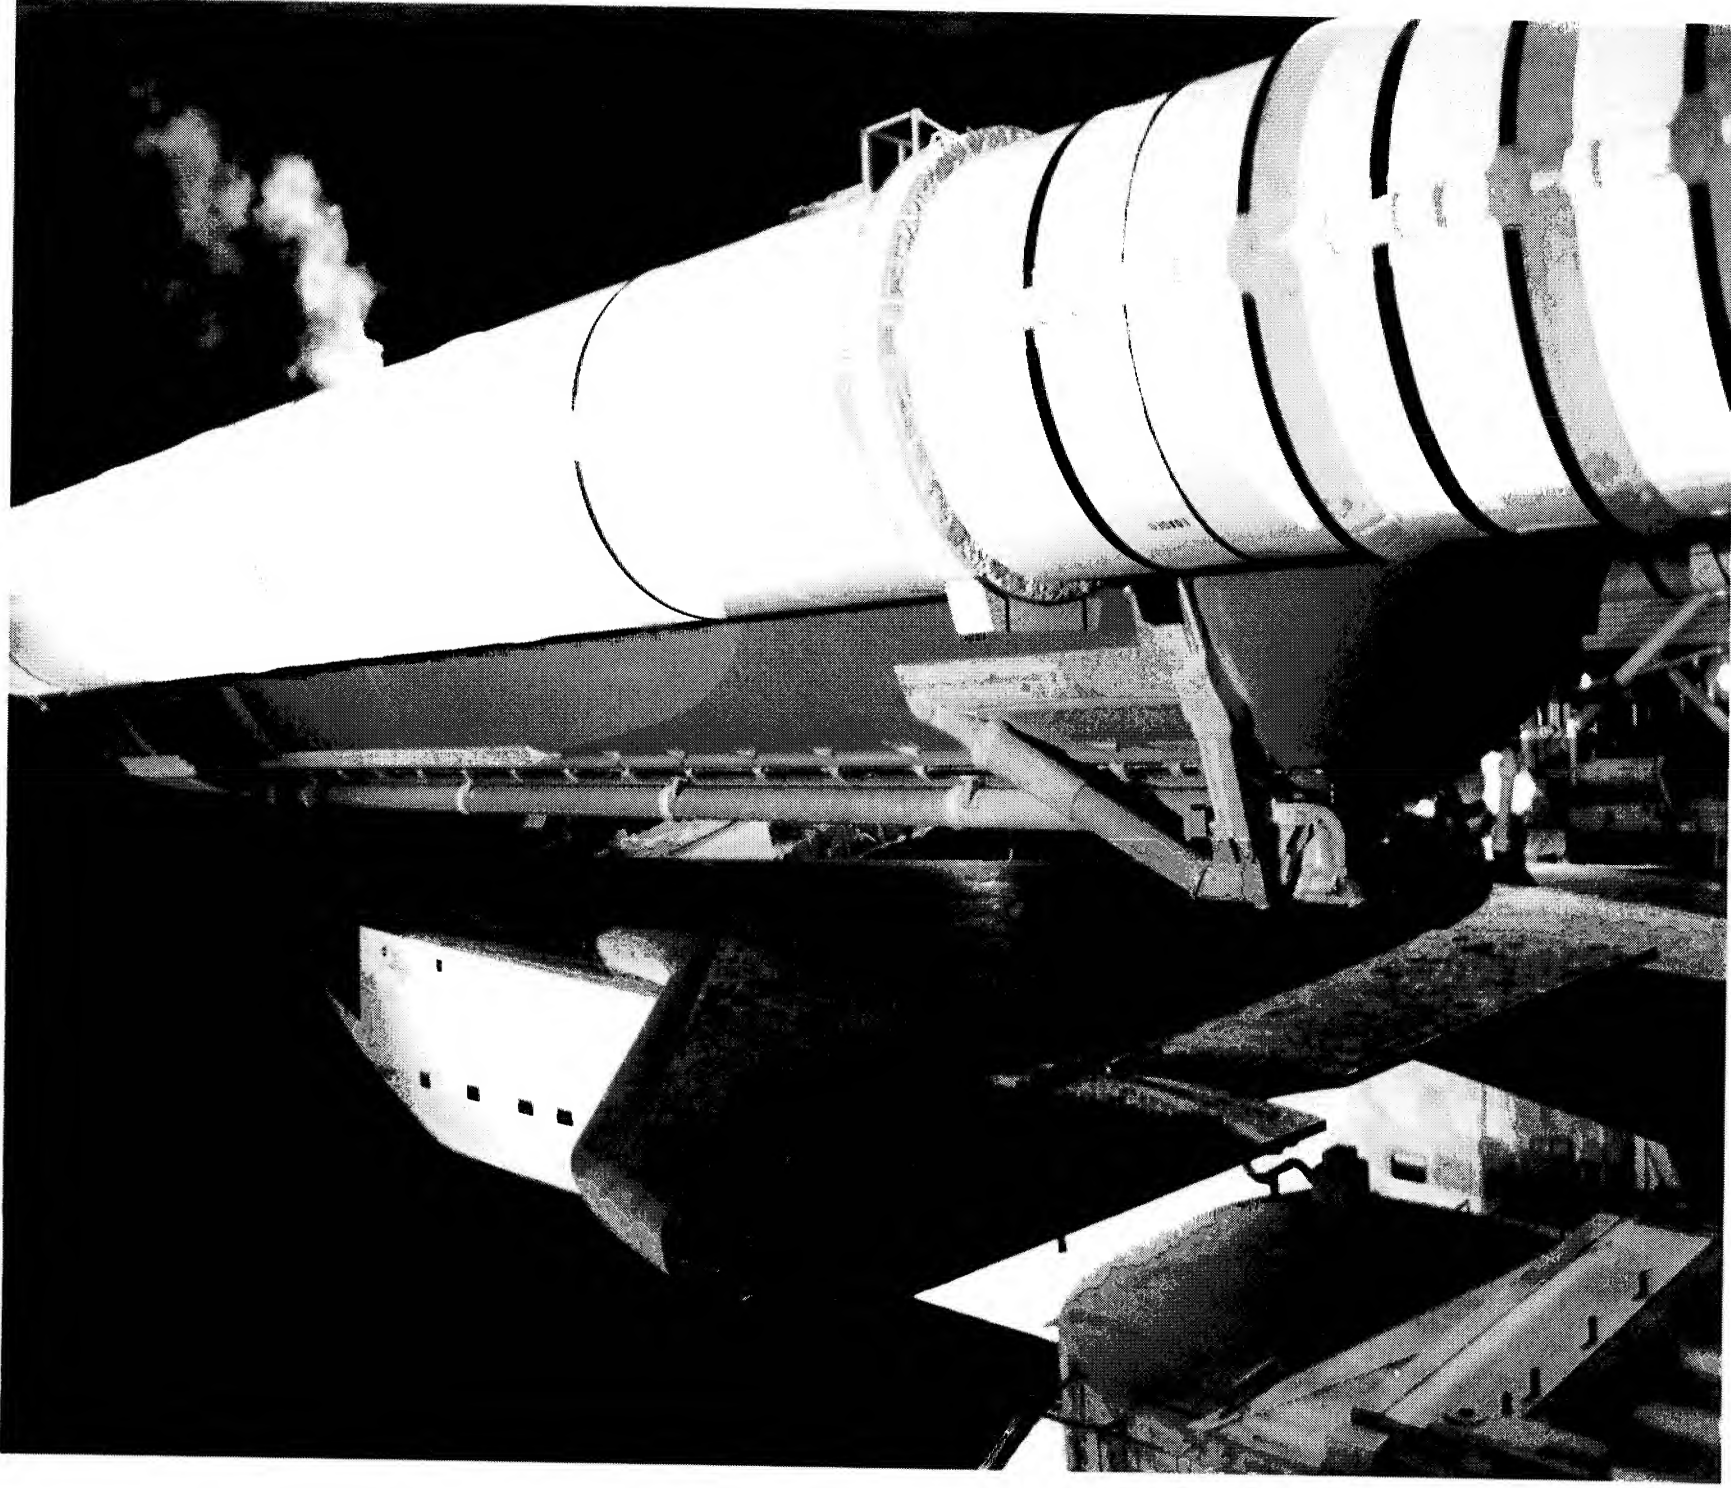
Overall view of the LH2 tank +Y+Z quadrant. Minimal ice/frost  
had formed on the ET/OPB LO2 umbilical.

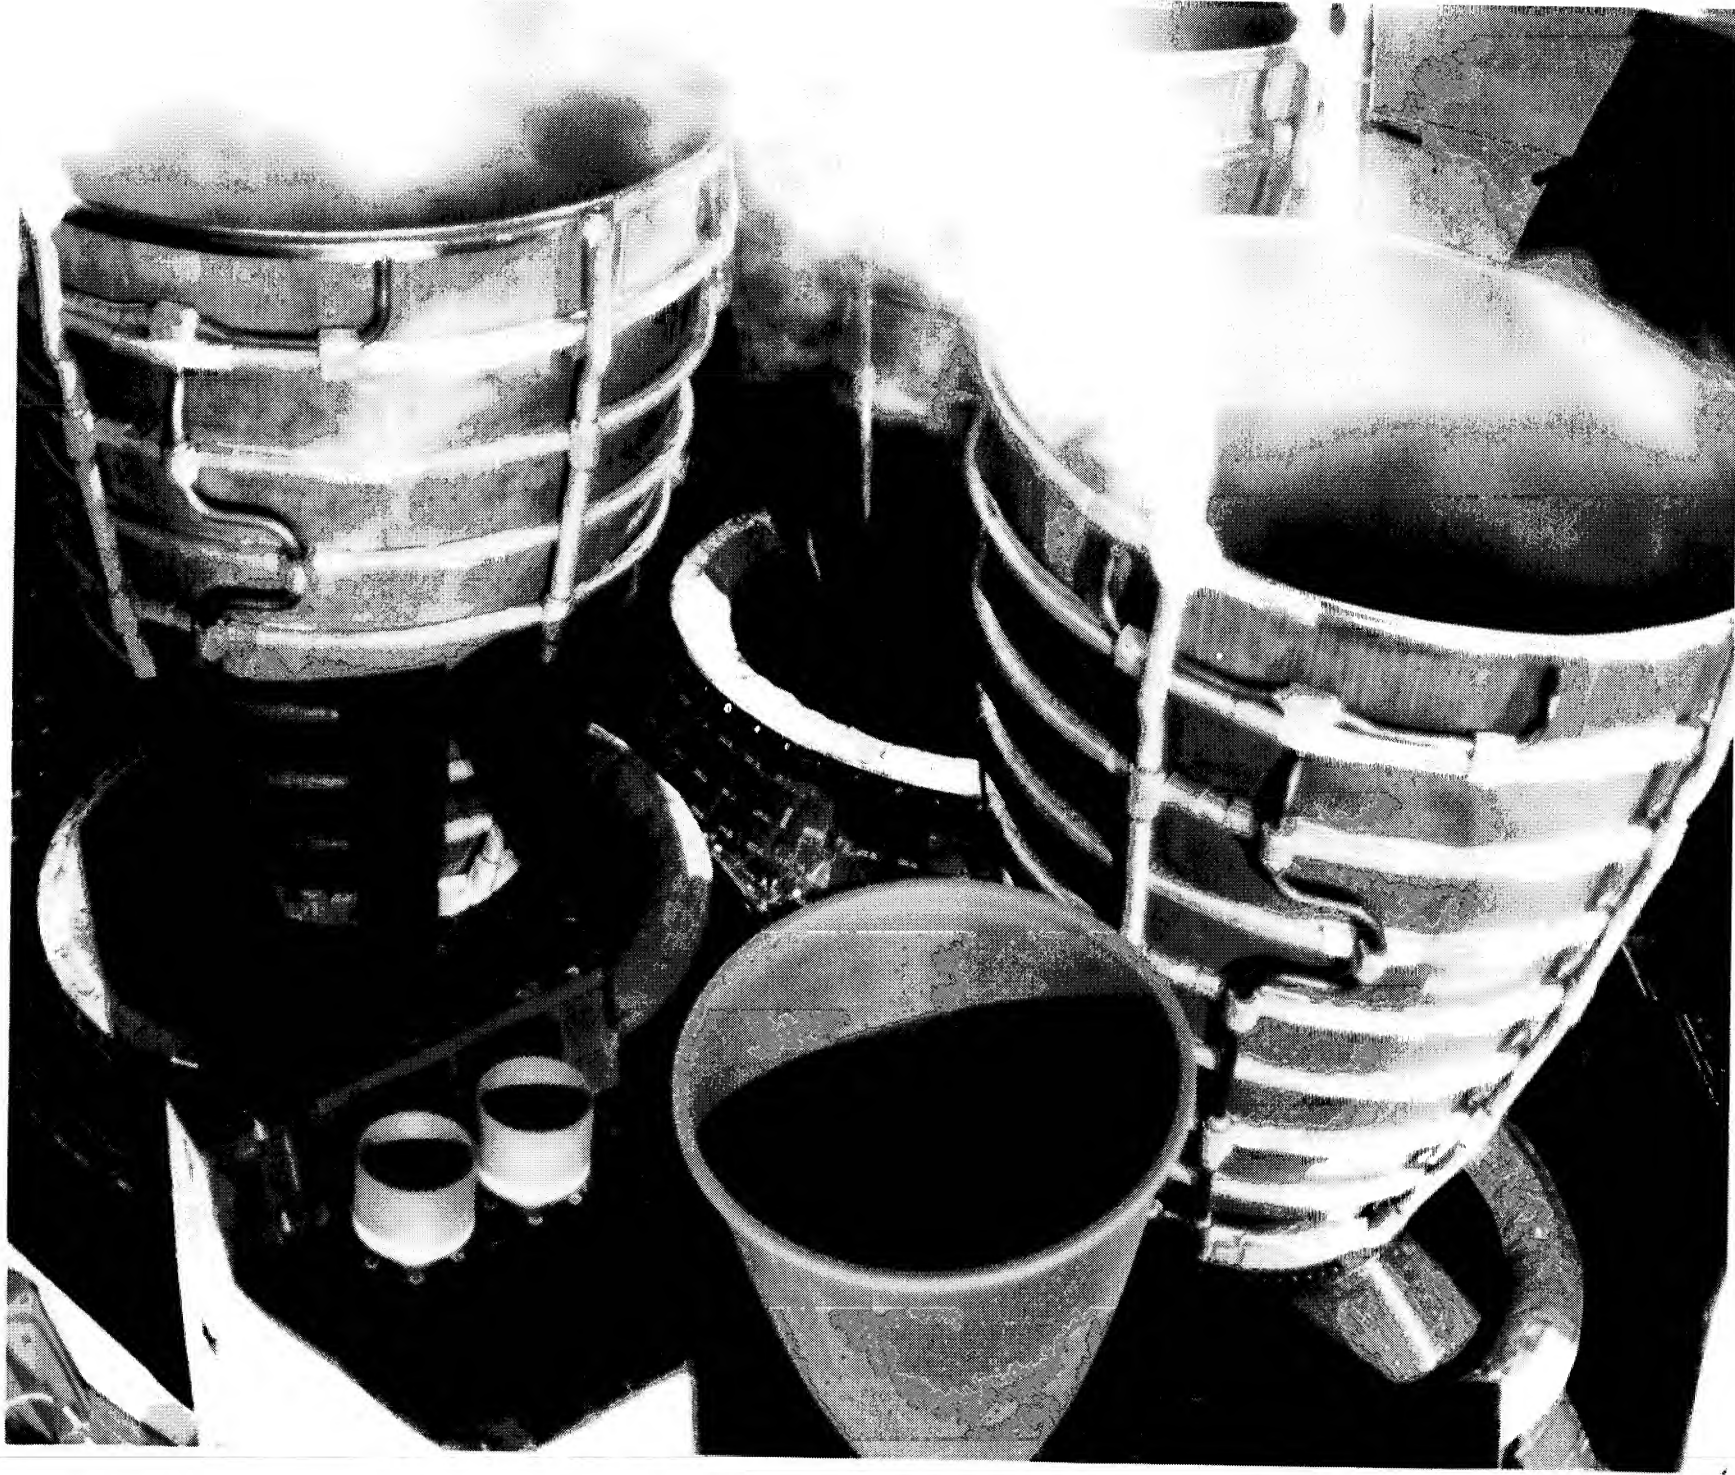
Overall view of SSME's. Note frost line on the engine mounted  
heat shield interface of SSME #2.

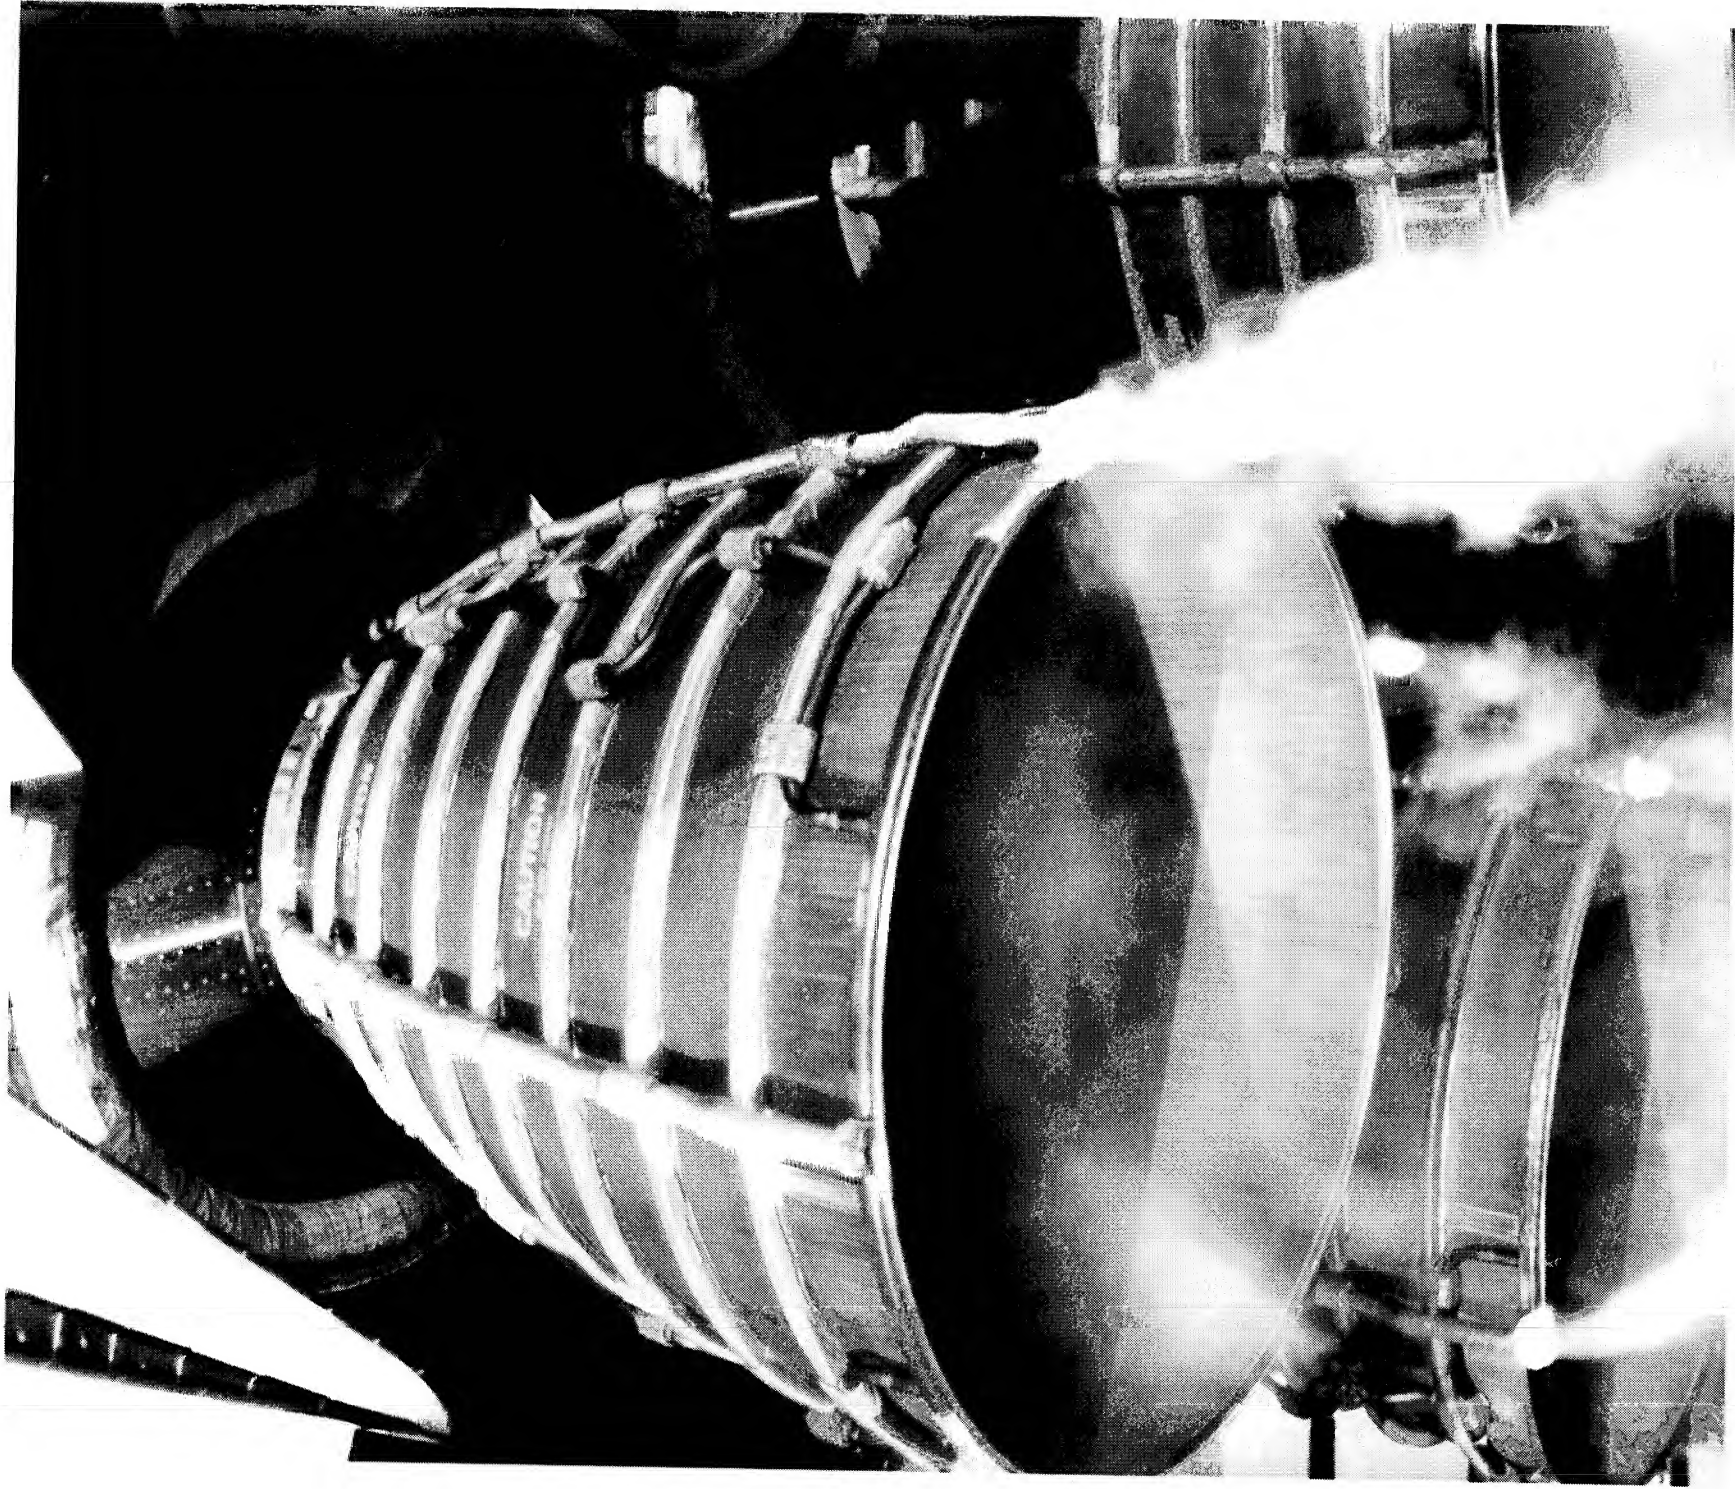
GOX vapors from the drain line are blown into the SSME nozzle by wind and may be misconstrued as a leaking SSME LO2 valve.

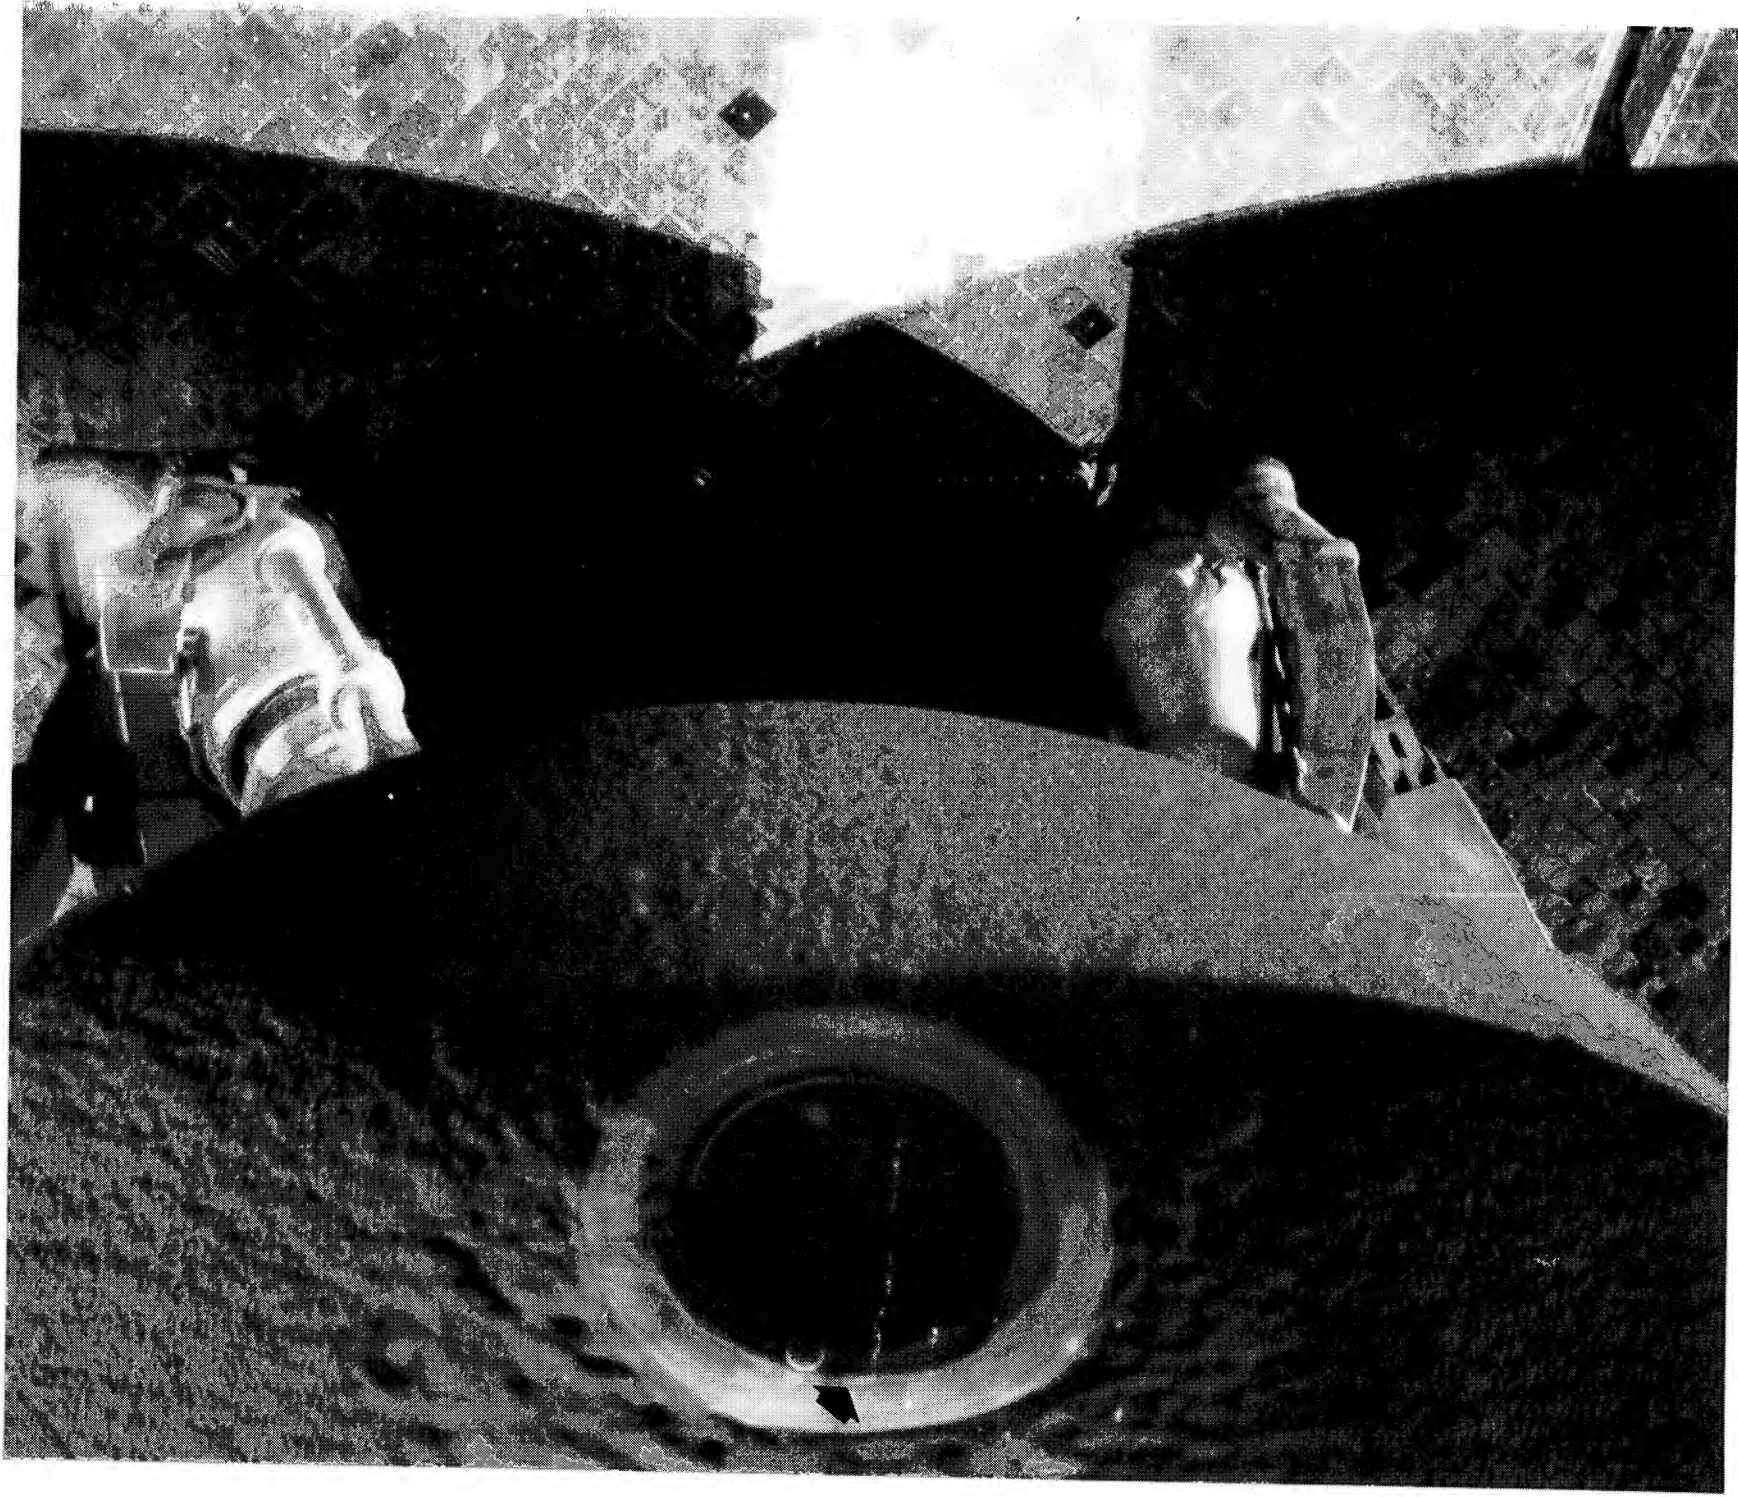
Ice formed on the aft side of the LO<sub>2</sub> umbilical. Ice is present in the LH<sub>2</sub> recirc line bellows, but not in the feedline bellows. Note stream of condensate falling from the manhole cover (arrow).
